Milwaukee County Committee of the Whole Public Hearing February 24, 2016

The Domes in Mitchell Park Conservatory

File # 16-136

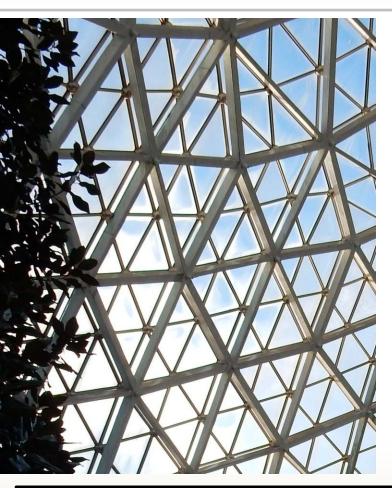
Domes Construction

5,100 Hub Connections 1,700 Per Dome

<u>'Beehive' vs. Geodesic</u>: Geodesic domes typically do not entail concrete frame with steel base plates.
